## Air Transat Flight 236

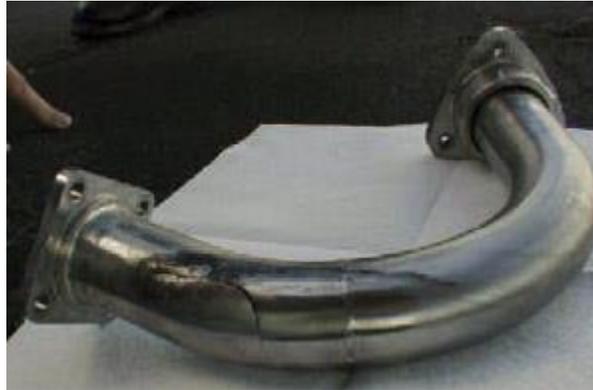
Photo of removed fuel line showing crack

The accident investigators determined that the fuel leak leading to the fuel exhaustion and dual engine flameout on Air Transat TSC236 was caused by a crack in the right engine fuel line. The crack was approximately three inches long (80 mm) and was created by the fuel line rubbing against an adjacent hydraulic line.

The rubbing was a result of an interference created by the use of mismatched fuel and hydraulic lines during replacement of the right engine on the accident airplane.

The interference was caused by the incomplete incorporation of a Rolls-Royce service bulletin that detailed instructions for replacement of fuel and hydraulic tubes necessary for the installation of improved model hydraulic pumps.

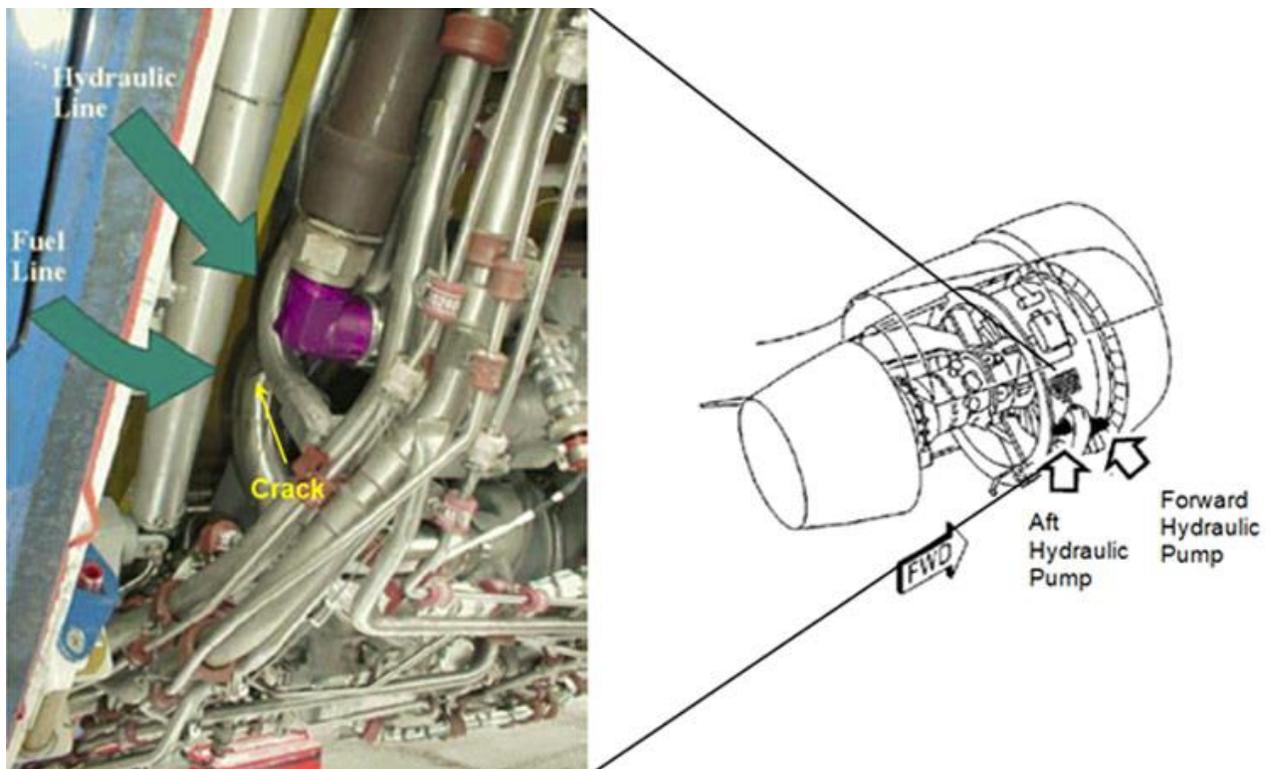
## Accident aircraft hydraulic and fuel line installation

Interference between the hydraulic pump and the adjacent fuel tube was the first indication of a problem with the installation of the post-mod hydraulic pumps from the original engine on the pre-mod replacement engine.

Both segments of the post-mod fuel tube assembly were taken from the removed engine and installed on the replacement engine. The different shape and routing of the new fuel line eliminated the interference that previously created difficulties installing the post-mod hydraulic pump. However, the pre-mod hydraulic tube received with the loaned engine was retained.

The installing maintenance technician recalled the hydraulic line had the tendency to spring back when trying to achieve the required separation between it and the fuel line taken from the original engine. However, he stated that he could easily obtain the clearance by positioning and holding the hydraulic tube while tightening the B-nut to hold it in place. No other installation difficulties were reported. Considering the hydraulic system working pressure of 3,000 psi and the pump pulsation, the accident investigators considered it feasible that any clearance between the hydraulic and fuel lines at installation on the occurrence aircraft would have vanished once the flexible hydraulic line was pressurized. The installation of the post-mod hydraulic pump, the pre-mod hydraulic tube, and the post-mod fuel tube assembly resulted in a mismatch between the fuel and hydraulic tubes.

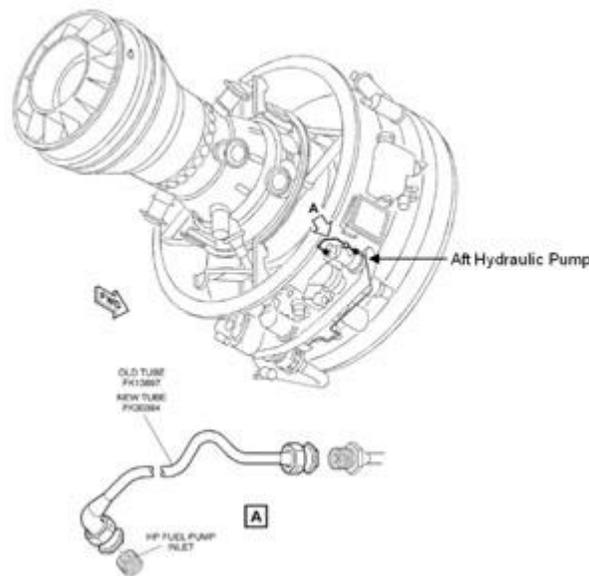
The larger hydraulic pump housing created an interference between the hydraulic line and the adjacent engine fuel line. The engine build-up service bulletin replaced three fuel tubes and two hydraulic tubes for the front and rear hydraulic pumps in order to eliminate the interference.

The Rolls-Royce hydraulic pump replacement service bulletin clearly required the engine build-up service bulletin to be accomplished prior to, or concurrently with, the hydraulic pump replacement. The engine build-up service bulletin stated that it was essential that the fuel and hydraulic tubes be fitted as a set.

Figure from Rolls-Royce engine build-up service bulletin showing routing of revised fuel line in vicinity of aft hydraulic pump
