Electrical short circuit and forward cargo compartment smoke event involving Boeing 777-300ER, A6-ETR

About 530 km north-north-west of Adelaide, South Australia, 14 October 2017

ATSB Transport Safety Report
Aviation Occurrence Investigation
AO-2017-101
Final – 22 August 2018

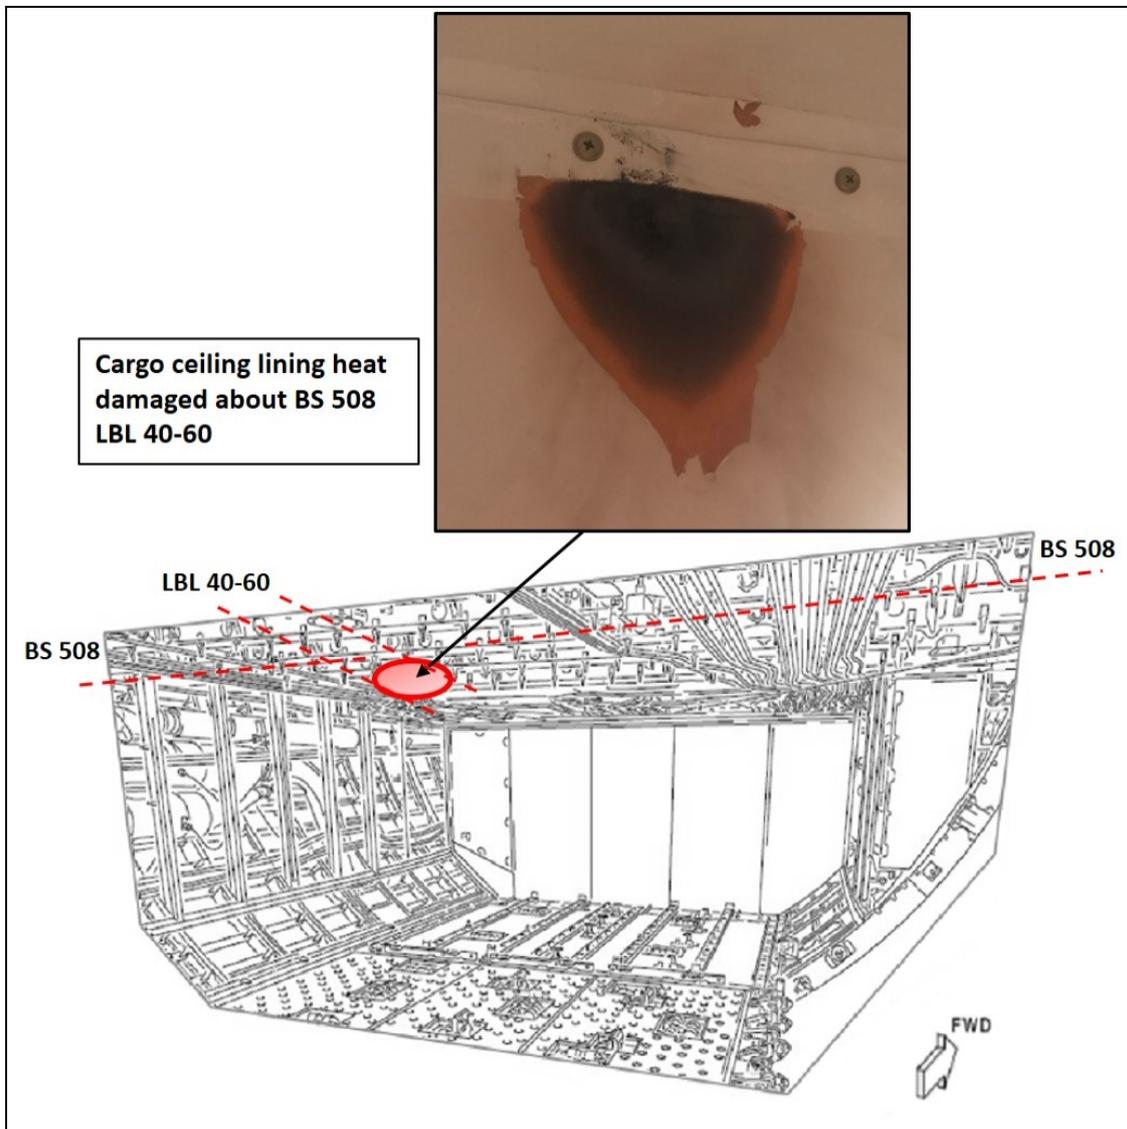
Figure 1: Illustration showing aircraft structure in the forward cargo hold in relation to heat damage from electrical arcing about BS 508

Once the forward cargo compartment was emptied of cargo, maintenance engineers inspected the cargo hold for evidence of fire. A small quantity of soot was identified in the cargo ceiling area, between the fiberglass ceiling panel and fiberglass joint sealing tape about aircraft body station (BS) 508 (Figure 1).

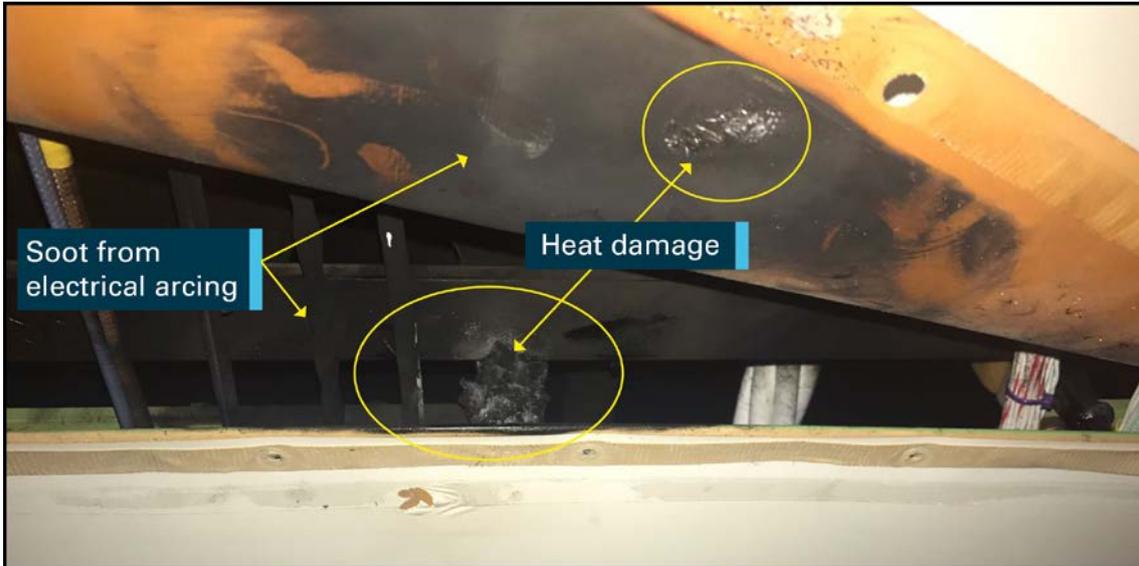
Figure 2: Damaged floor beams, webs and wiring covered in soot with ceiling panel opened

The ceiling panels were removed where soot was identified in the area between the lower side of the cabin floor and the upper side of the cargo-ceiling panel (Figure 2). Inspection of that area

found heat damage and chafed 115-volt electrical wire in wiring loom P/N W5279-3002R-12 (W5279), which supplied power to the right lower recirculation fan. The chafing enabled the wire core to come in contact with a cargo ceiling panel retainer screw where the short circuited wire tracked through the polyetheretherketone resin (PEEK) stand-off brackets and carbon fibre floor beam.

In consultation with Boeing and operator’s aviation regulator, the United Arab Emirates General Aviation Authority, the operator temporarily repaired the wiring and the damage to the floor beams were evaluated. The operator conducted a non-revenue flight (nil passengers) where they flew the aircraft back to the UAE for the purpose of further inspections and permanent repairs.

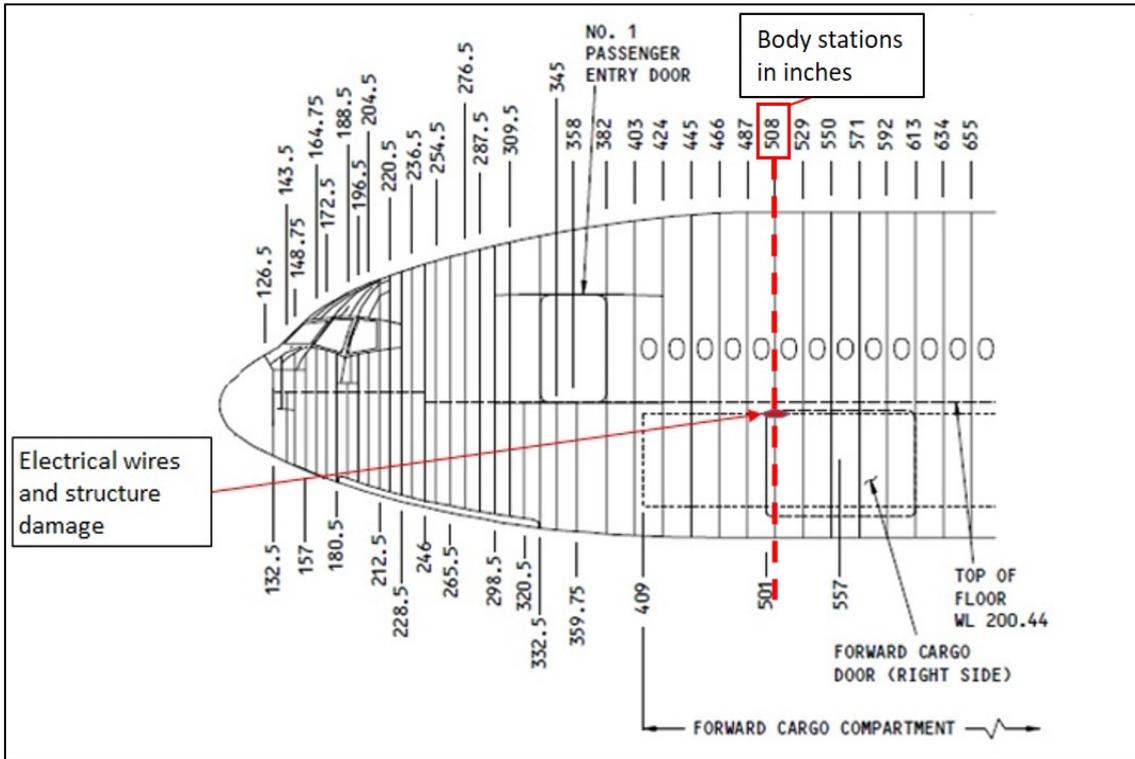
Figure 3: Boeing 777 aircraft showing the approximate location of the heat damaged ceiling panel, soot and heat damaged wiring loom

A detailed inspection between the forward cargo ceiling and passenger floor was conducted at the operator’s maintenance facility in the UAE. Wire bundle W5279, located at about BS 508 was found to have been incorrectly routed. Consequently, the wires had come into contact with screws and nutplates used to close out the cargo-ceiling panel to the ceiling standoff clips.

Over a prolonged period of time, the 115V recirculation fan wire located within that bundle chafed through the insulation coating, allowing the wire to short circuit. The electrical wiring and fourteen of the cargo ceiling panel standoff clips manufactured from PEEK were heat damaged. Sections of the carbon fibre beam web and beam flange at BS 508 between the left buttock⁷ lines 40 to 60 were also found to be heat damaged and delaminated between 6 and 7 percent in three locations where the current tracked (Figure 3).

Boeing determined that the wiring loom W5279 was likely to have been incorrectly positioned during the aircraft build in 2013. Boeing reported that this was the fifth reported incident involving wire chafing and arcing in the cargo area of a Boeing 777 aircraft. However, this was the first event that triggered the cargo fire warning system and that had been detected in flight. In all of these cases, the wiring loom had been installed incorrectly during manufacture, allowing screws to chafe wires and short circuit.

In addition, Boeing has issued Service Bulletin 777-24-0157, which would require operators to inspect for and correct similar conditions that led to this occurrence. Service Bulletin 777-24-0157 relate to all Boeing 777-200, 777-200LR, 777-300ER aircraft line numbers 1-1527 inclusive.

Boeing Engineering performed an investigation of all cargo ceiling wire bundle installation engineering drawings. Boeing will add additional spacing as a precaution when wire bundles are in close proximity to ceiling liner screws.
