C-130A, Walker, California - N130HP crash scene from NTSB report

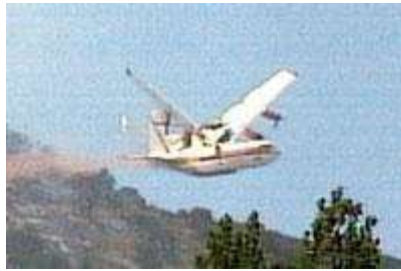
Lockheed C-130A Hercules registration N130HP, call sign Tanker 130, was flying against the Cannon Fire, near Walker, California on June 17, 2002, when it experienced structural failure of the center wing section, causing both wings to fold upward and separate from the aircraft. The fuselage rolled and crashed inverted, killing the three crewmen on board.

The NTSB investigated the crash and determined that the accident was caused by a structural failure that occurred at the wing-to-fuselage attach point, with the right wing failing just before the left.

The investigation disclosed "evidence of fatigue cracks in the right wing's lower surface skin panel, with origins beneath the forward doubler. The origin points were determined to be in rivet holes which join the external doubler and the internal stringers to the lower skin panel.

These cracks, which grew together to about a 12-inch (30 cm) length, were found to have propagated past the area where they would have been covered by the doubler and into the stringers beneath the doubler and across the lap joint between the middle skin panel and the forward skin panel
