Electrical Wiring Inspection Observations - EWIS

The following was observed on a single aircraft during a general inspection to review EWIS integrity.

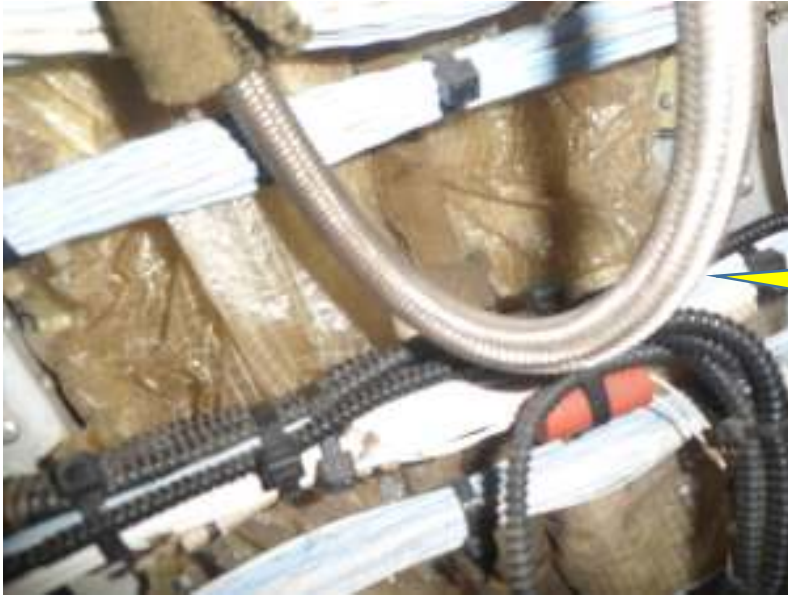
Captains oxygen pipe is in direct contact with wiring in several places !

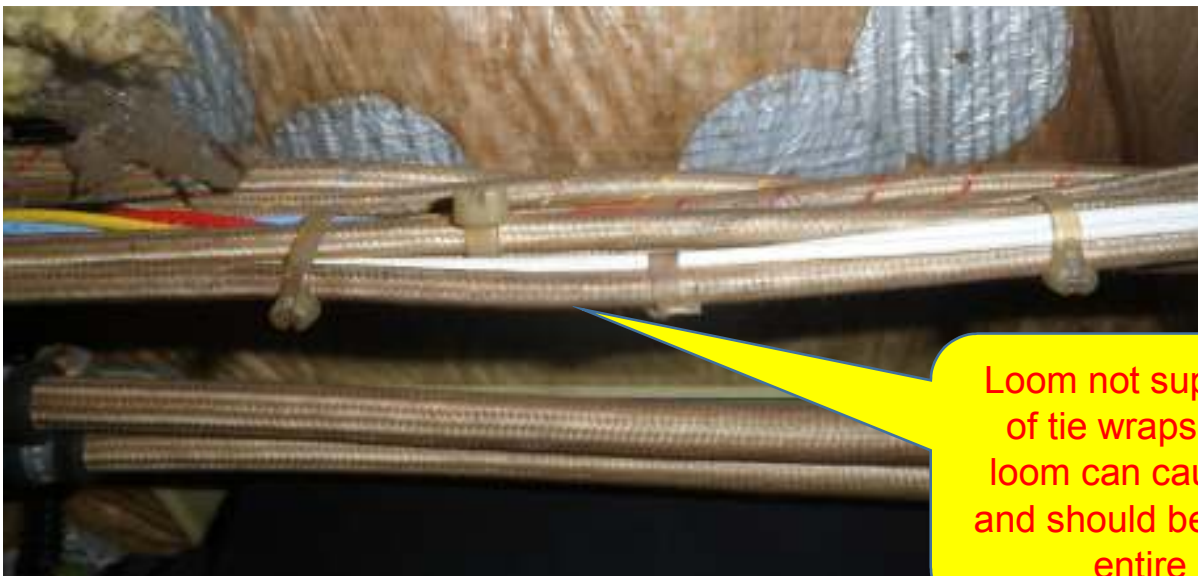
Loom not supported use of tie wraps within the loom can cause chafing and should be around the entire loom

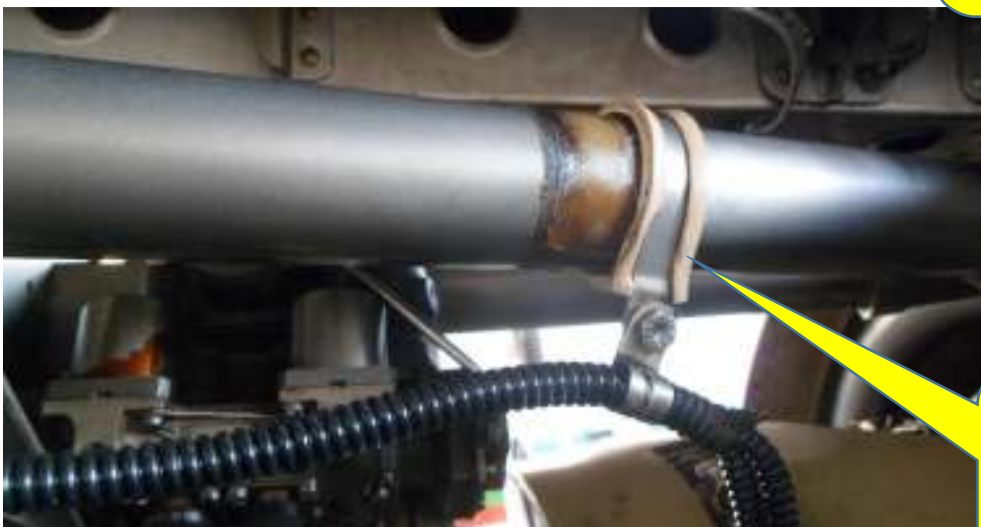
P Clip Migration all P Clips should be of the correct size and firmly attached e entire loom

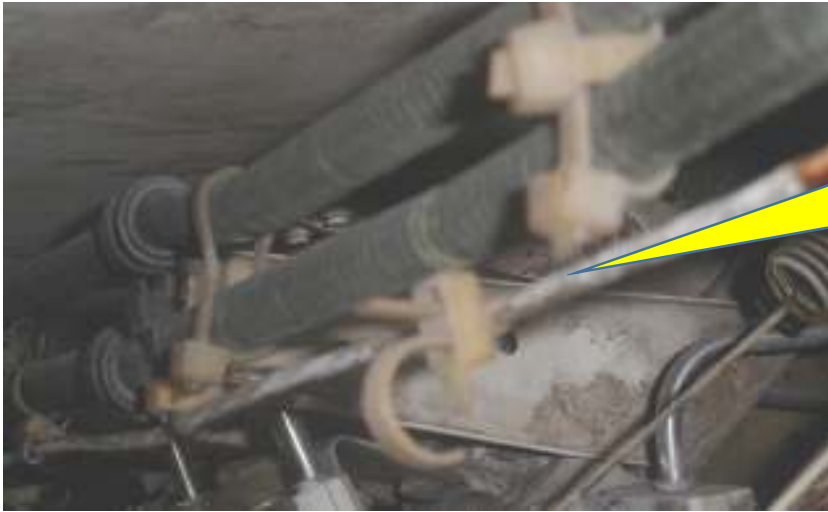
Tie Wraps can age harden fatigue and fail – pay particular attention during Inspection

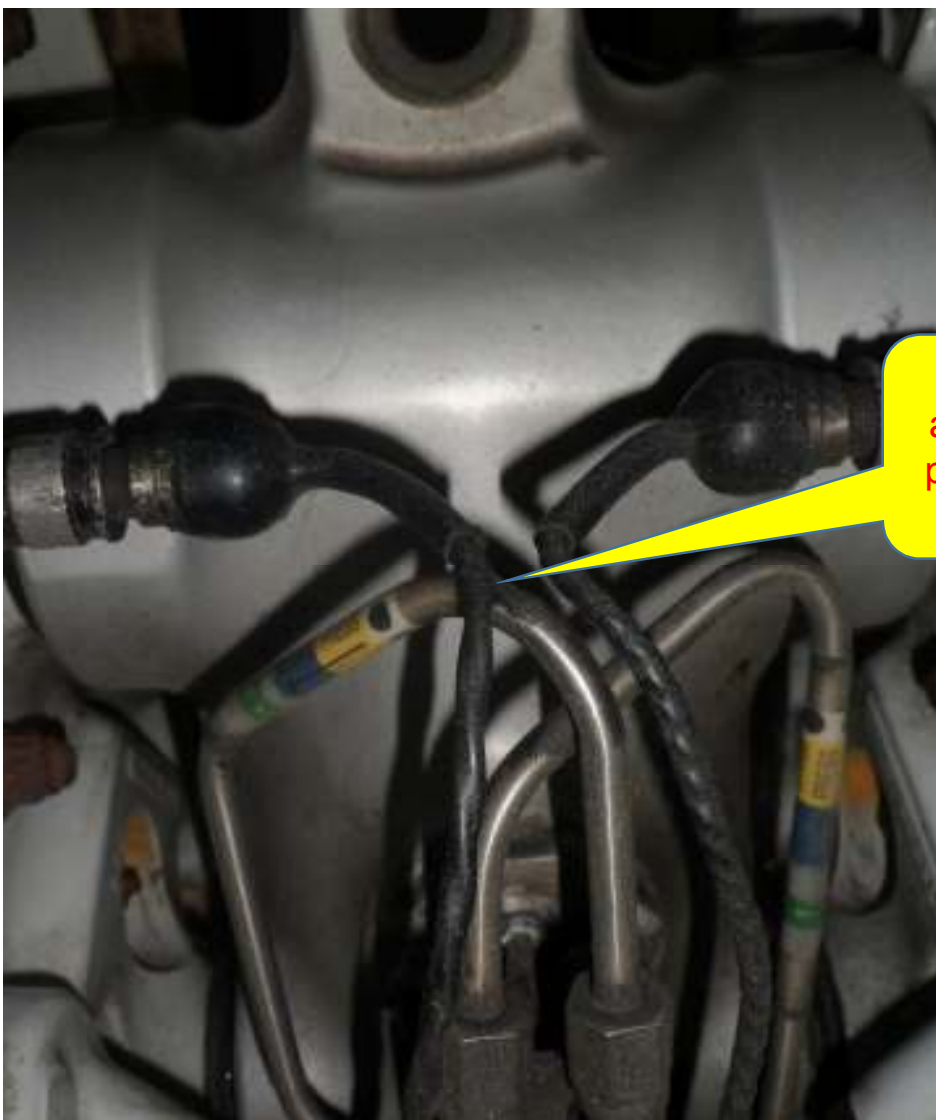
Any point of contact can allow wiring to chafe – so pay close attention during your inspection

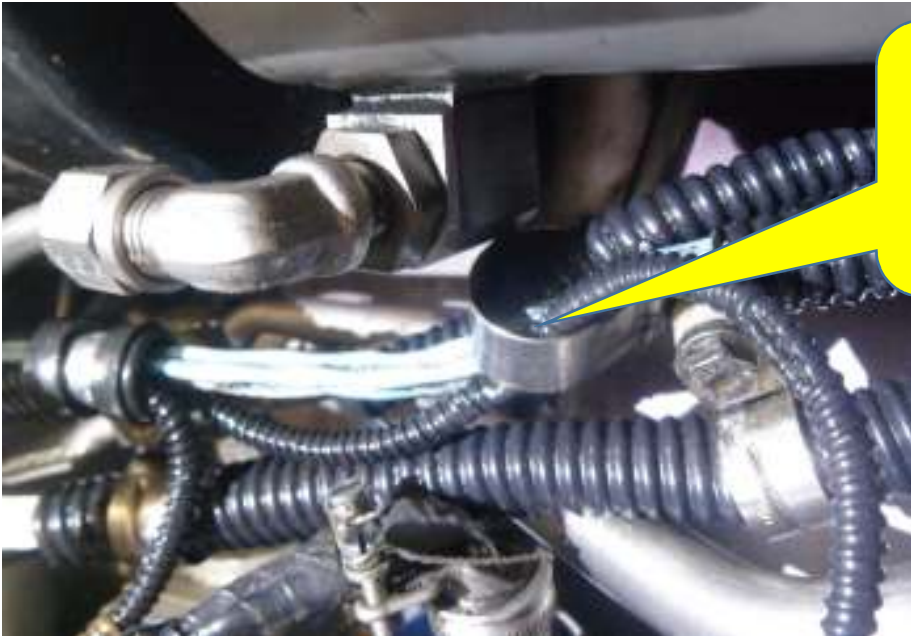
It is most important to ensure that all clips secure the cables effectively otherwise chafing can occur

The braided sleeve ensures the protection of the conduit if it is damaged it should be replaced

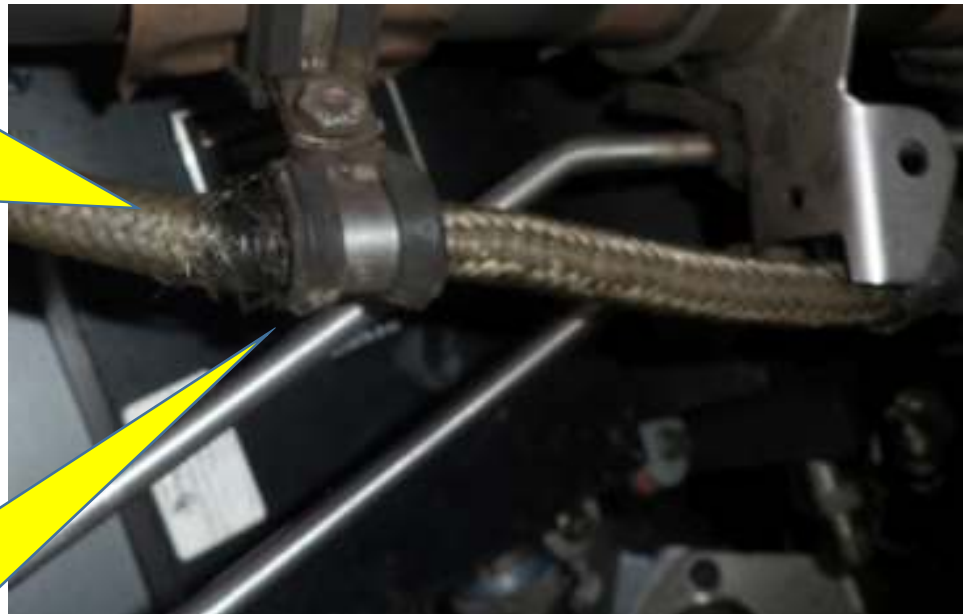
No pressure should exist between electrical p clips and fittings – fixtures, pipes or tubing

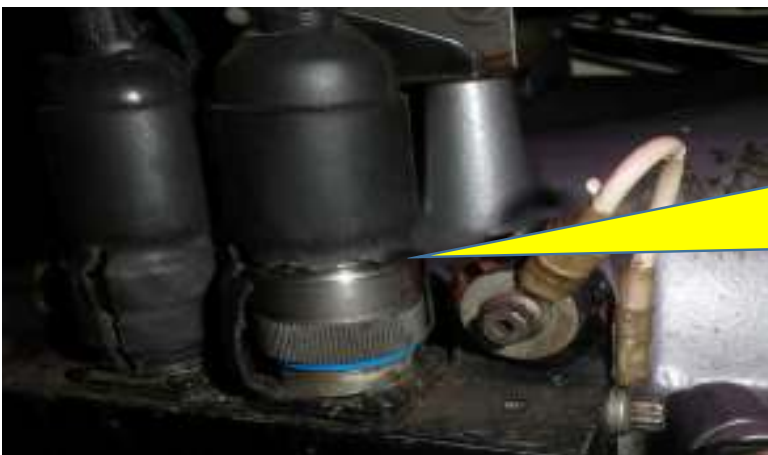
The integrity of sleeving designed to prevent the ingress of fluids and moisture into connectors must

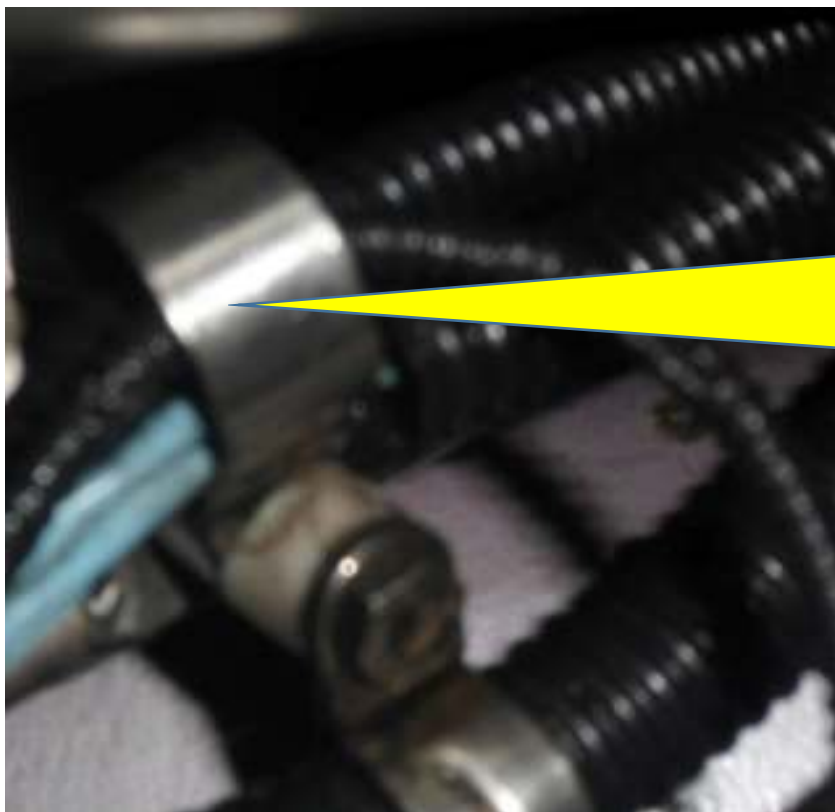
P Clips must be correct IAW IPC or other approved data and must afford appropriate support and protection, oversize P Clips pose a threat

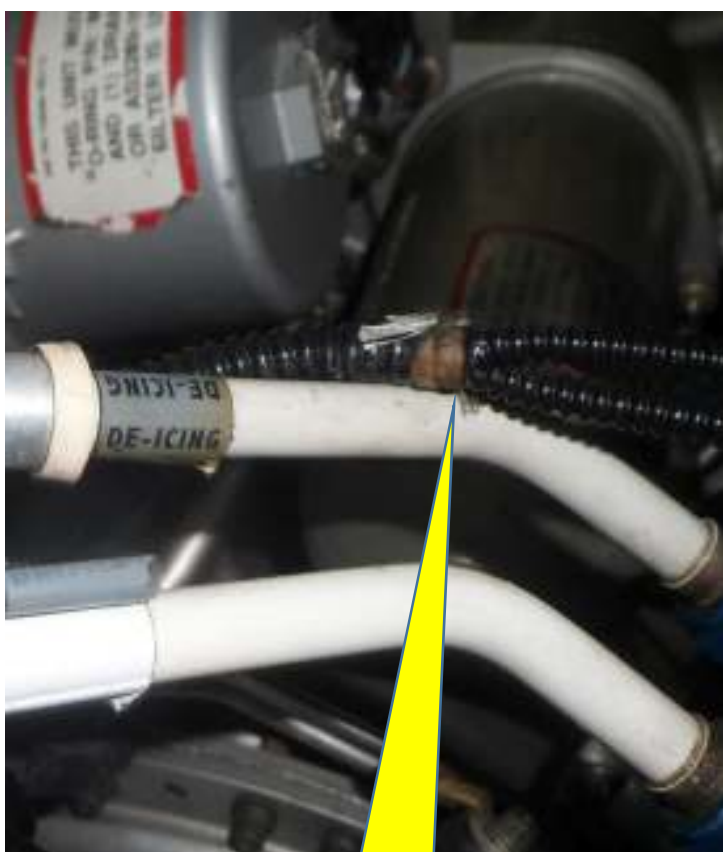
Be concerned when you see contact or potential contact

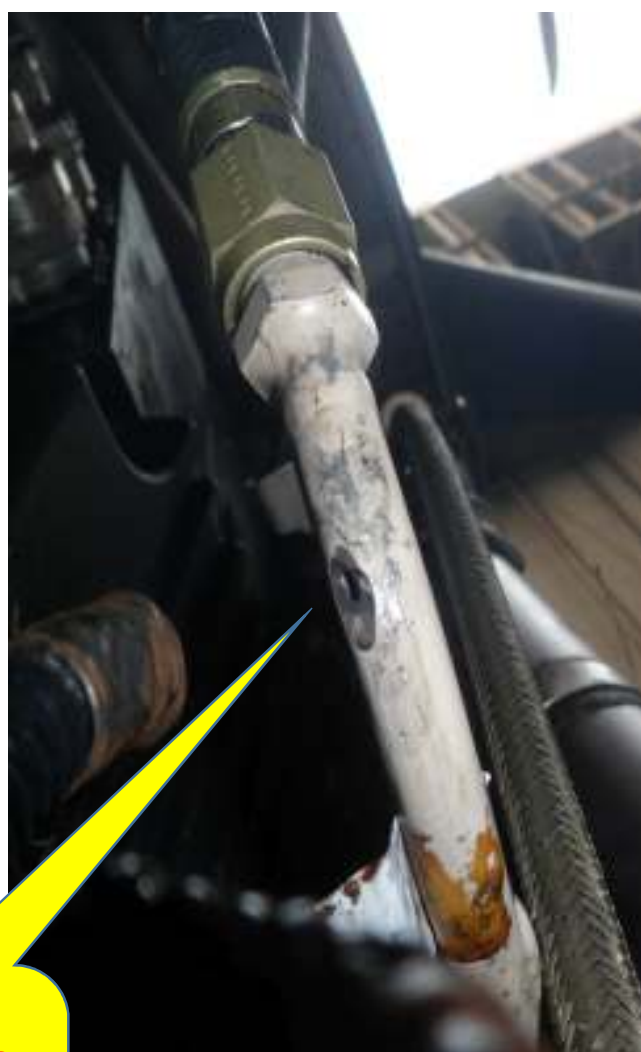
It may be concealing a problem (Engine De-icing sense line)
