Air Transat Flight 236

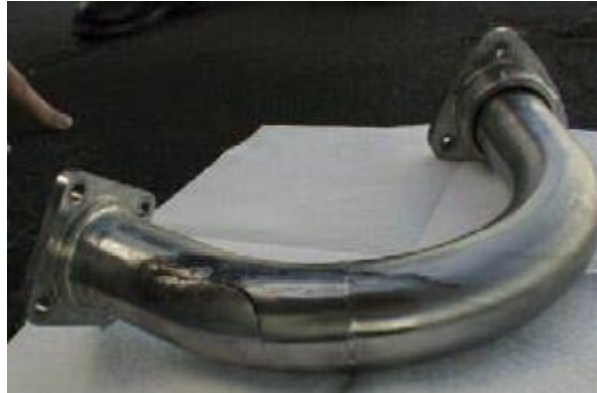
Photo of removed fuel line showing crack

The accident investigators determined that the fuel leak leading to the fuel exhaustion and dual engine flameout on Air Transat TSC236 was caused by a crack in the right engine fuel line. The crack was approximately three inches long (80 mm) and was created by the fuel line rubbing against an adjacent hydraulic line.

The rubbing was a result of an interference created by the use of mismatched fuel and hydraulic lines during replacement of the right engine on the accident airplane.

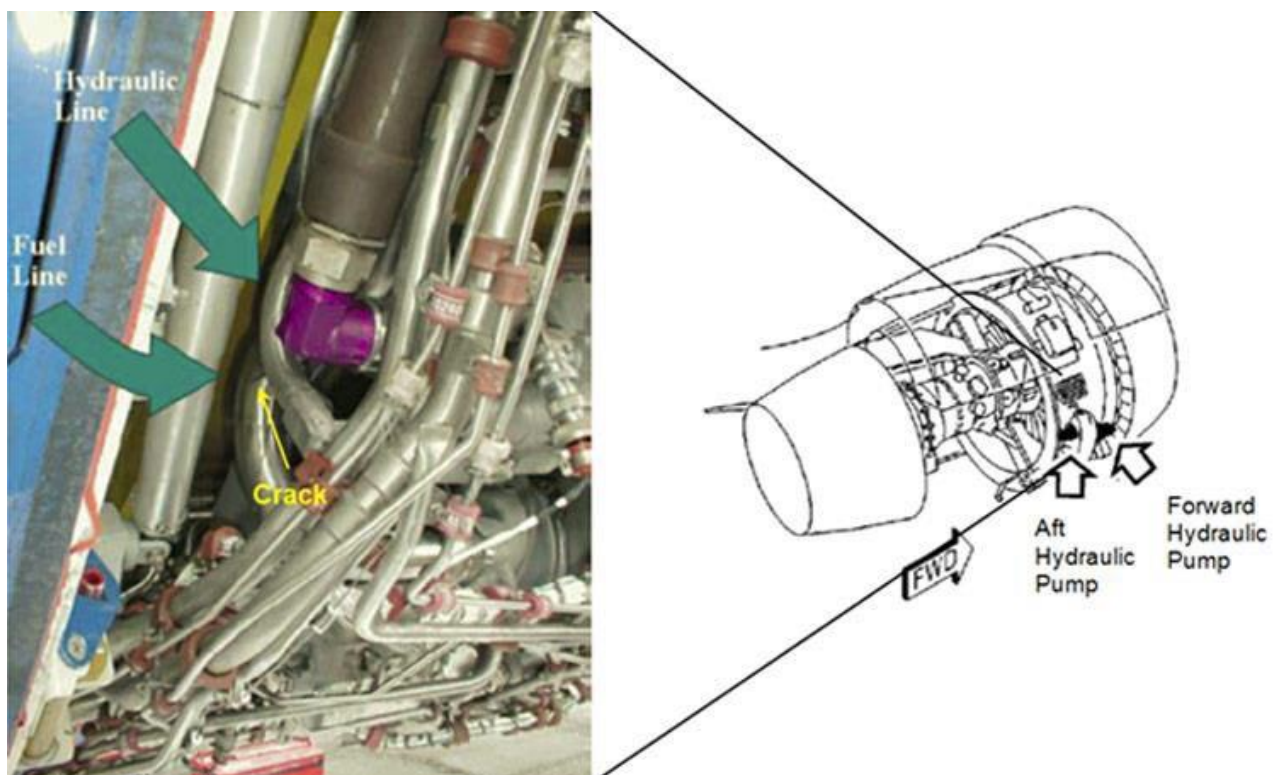
Accident aircraft hydraulic and fuel line installation

Interference between the hydraulic pump and the adjacent fuel tube was the first indication of a problem with the installation of the post-mod hydraulic pumps from the original engine on the pre-mod replacement engine.

Both segments of the post-mod fuel tube assembly were taken from the removed engine and installed on the replacement engine. The different shape and routing of the new fuel line eliminated the interference that previously created difficulties installing the post-mod hydraulic pump. However, the pre-mod hydraulic tube received with the loaned engine was retained.

The installing maintenance technician recalled the hydraulic line had the tendency to spring back when trying to achieve the required separation between it and the fuel line taken from the original engine. However, he stated that he could easily obtain the clearance by positioning and holding the hydraulic tube while tightening the B-nut to hold it in place. No other installation difficulties were reported. Considering the hydraulic system working pressure of 3,000 psi and the pump pulsation, the accident investigators considered it feasible that any clearance between the hydraulic and fuel lines at installation on the occurrence aircraft would have vanished once the flexible hydraulic line was pressurized. The installation of the post-mod hydraulic pump, the pre-mod hydraulic tube, and the post-mod fuel tube assembly resulted in a mismatch between the fuel and hydraulic tubes.

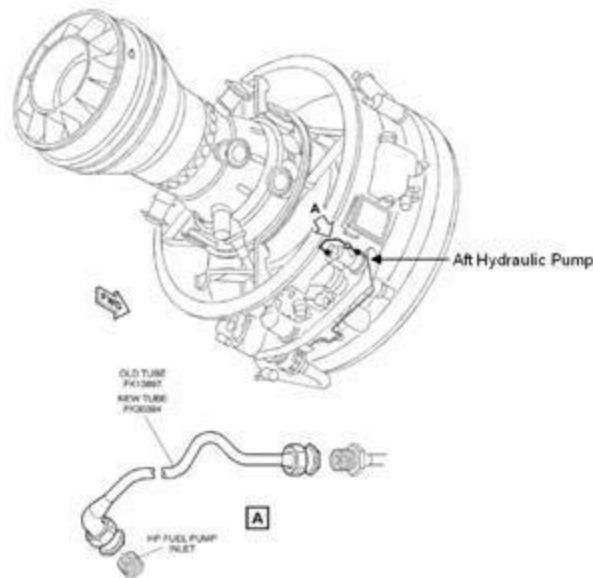
The larger hydraulic pump housing created an interference between the hydraulic line and the adjacent engine fuel line. The engine build-up service bulletin replaced three fuel tubes and two hydraulic tubes for the front and rear hydraulic pumps in order to eliminate the interference.

The Rolls-Royce hydraulic pump replacement service bulletin clearly required the engine build-up service bulletin to be accomplished prior to, or concurrently with, the hydraulic pump replacement. The engine build-up service bulletin stated that it was essential that the fuel and hydraulic tubes be fitted as a set.

Figure from Rolls-Royce engine build-up service bulletin showing routing of revised fuel line in vicinity of aft hydraulic pump
