China_Airlines_Flight_120

What Happened?

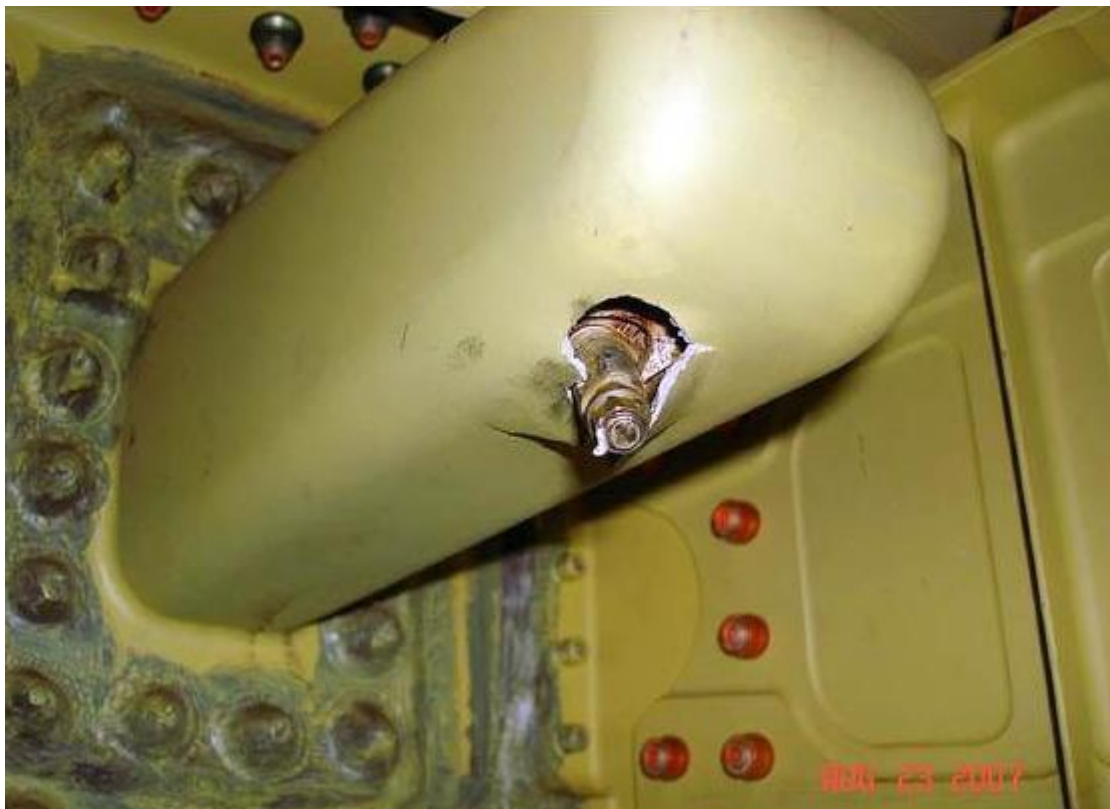
When the aircraft retracted the slats after landing at Naha Airport, the track can that housed the inboard main track of the No. 5 slat on the right wing was punctured, creating a hole. Fuel leaked out through the hole, reaching the outside of the wing.

The washer on the nut side of the assembly was omitted, following which the downstop on the nut side of the assembly fell off and then the downstop assembly eventually fell off the track.

It is considered highly probable that a factor contributing to the detachment of the downstop assembly was the design of the downstop assembly, which was unable to prevent the assembly from falling off if the washer is not installed.

Despite the fact that the nut was in a location difficult to access during the maintenance works, neither the manufacturer of the aircraft nor the company had paid sufficient attention to this when preparing the service letter and engineering order job card, respectively.

Also, neither the maintenance operator nor the job supervisor reported the difficulty of the job to the one who had ordered the job.
