**SAIB:** CE-17-05

**Date:** December 16, 2016

**SUBJ:** Electrical Power/Electrical Power System Wiring

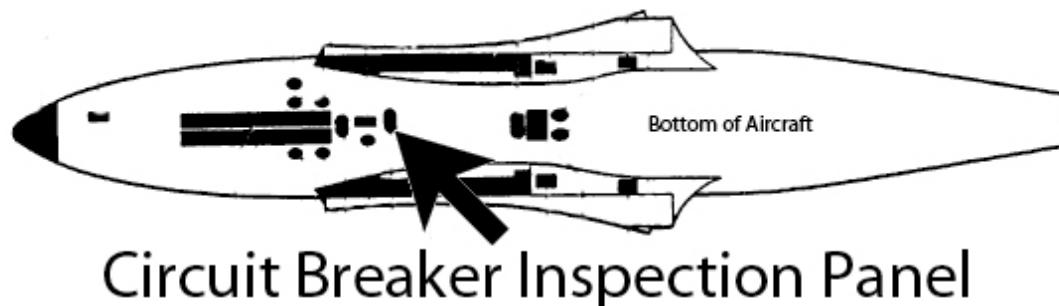
**Figure 1 – Location of Circuit Break Inspection Panel**

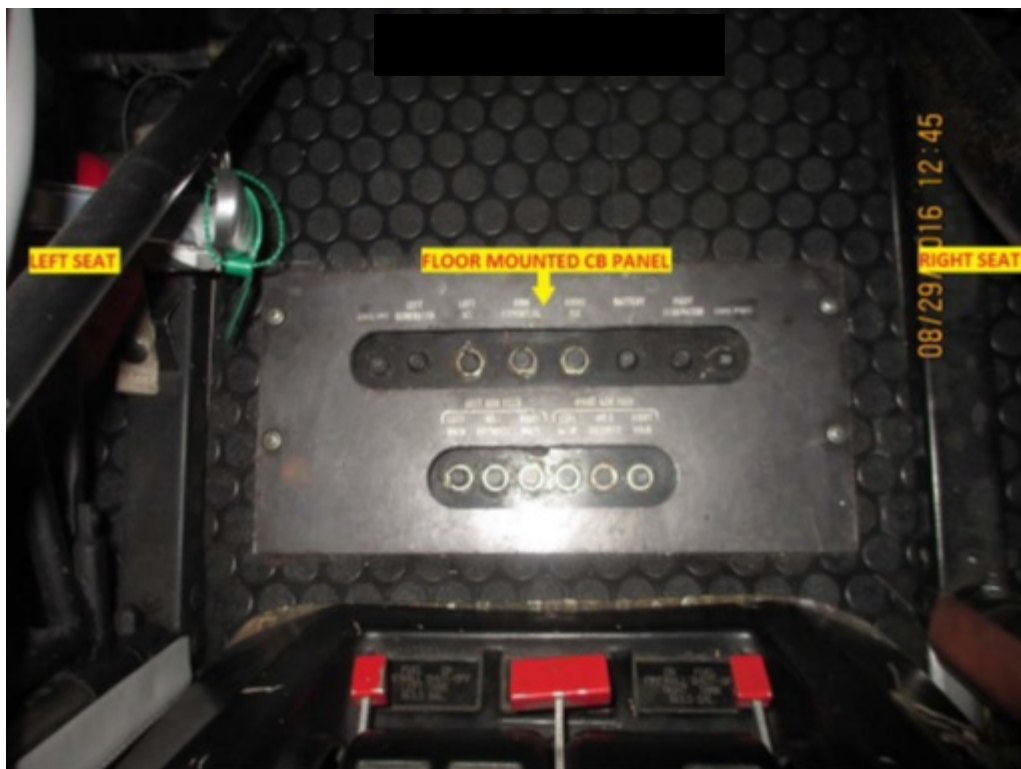
Figure 2 – Example of Floor Mounted CB Panel – Interior (1981 and later production)

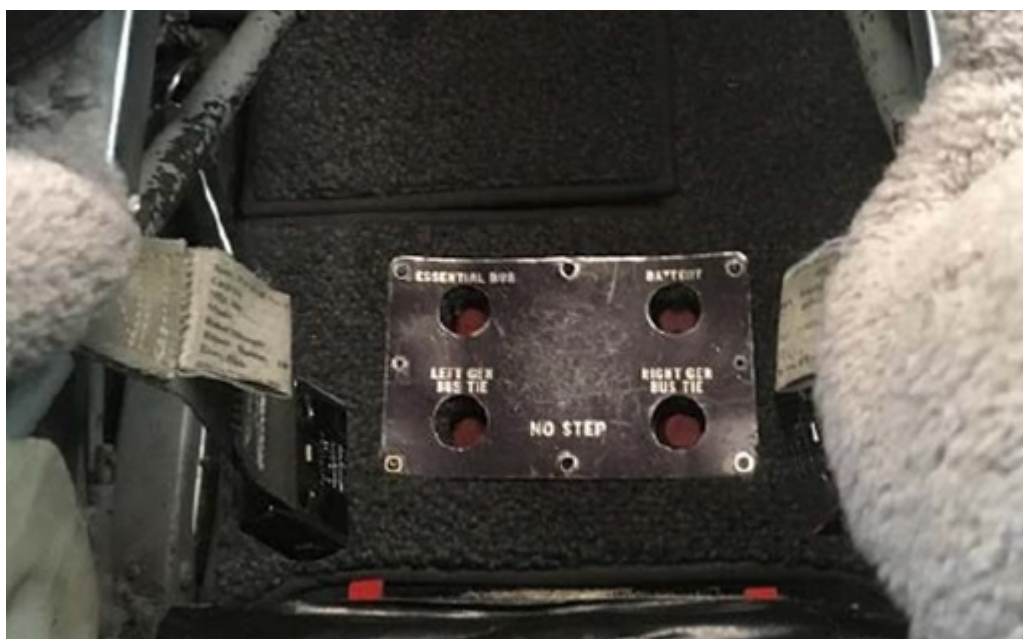
Figure 3 – Floor Mounted CB Panel – Interior (Typical of pre-1981 production)

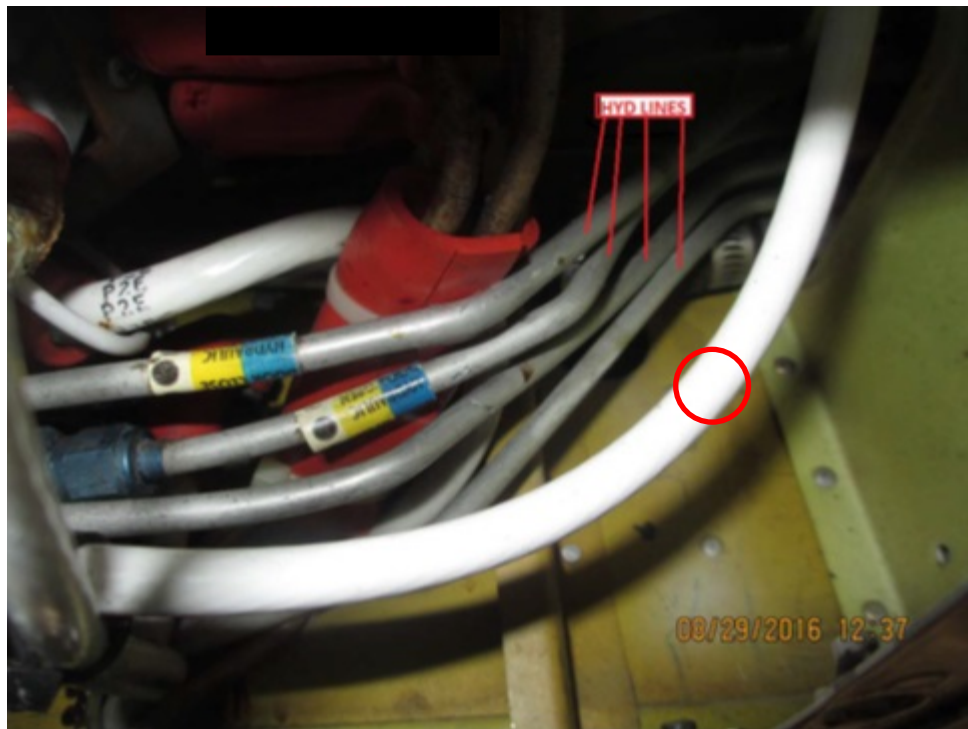
During inspections of multiple Piper Model PA-31T airplanes, several airplanes showed unacceptable wire separation from hydraulic lines and /or adjacent structure below the floor-mounted main power distribution CB Panel. The inspections also showed early signs of chafing, which can lead to thermal stress and arcing in an area where flammable liquids are routed. These conditions could sustain an uncontrollable fire in an inaccessible area below the pressurized deck. Photos of the area are shown in the following figures.

**Figure 4 – View of the Hydraulic Lines in close proximity with electrical wires**

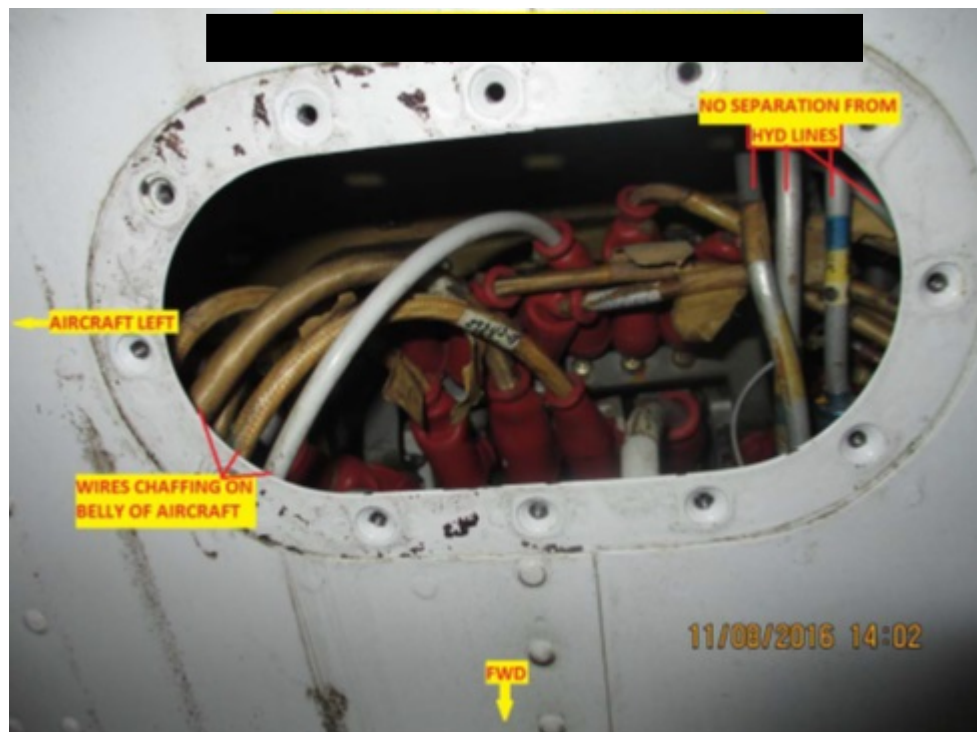
**Figure 5 – View of the Area with inspection panel removed**

- Inspections of the area shown in Figure 5, a mirror, a suitable light source or other equipment (small cameras, borescopes, magnification, etc.) capable of providing equal or better resolution.
- Inspections of the condition of all wiring.
- Repair or replacement of any wires with chafing, burning, breaks in insulation, corrosion, or any other apparent damage.
- Inspections for loose, corroded or broken terminals and repair or replacement on condition.
- A functional test on any electrical systems that were disturbed during any inspection.
- Reroute or rework as necessary to minimize the likelihood of chafing contact between adjacent components such as fluid carrying lines and airframe structure.
- Ensure proper hydraulic line and wire clearance is maintained. Use AC 43.13B – *Acceptable Methods, Techniques and Practices – Aircraft Inspection and Repair* as guidance.

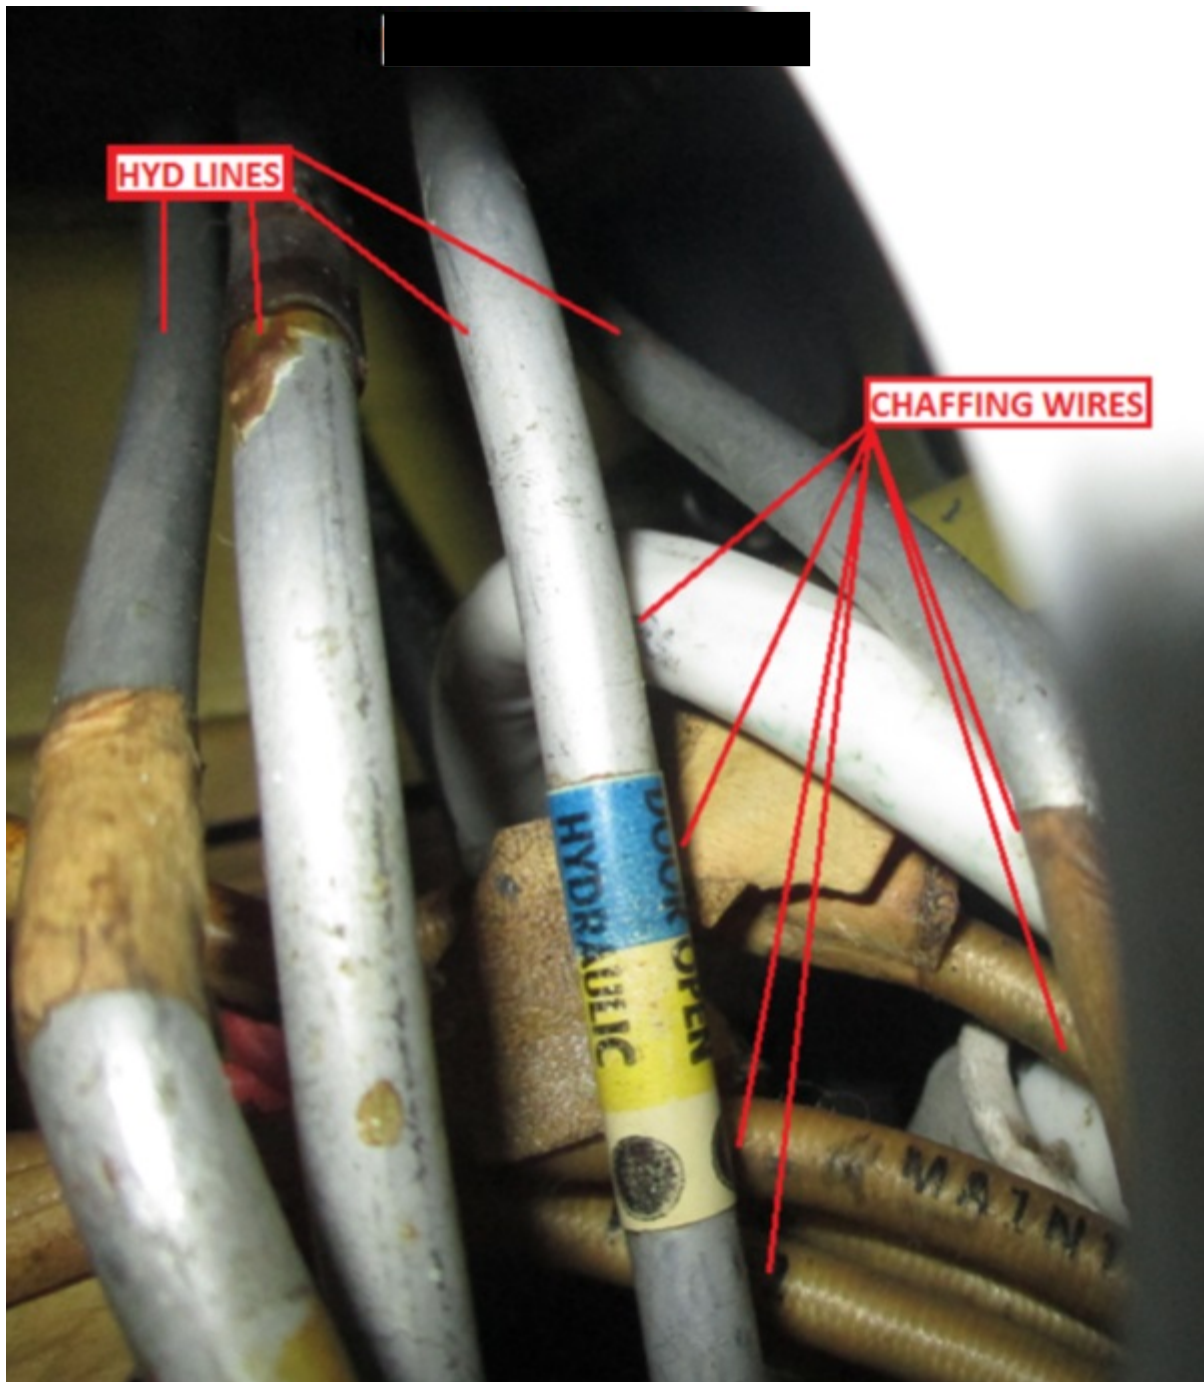
**Figure 6 – Chaffing wires on hydraulic lines**
