Alaskan Airlines Flight 261

Source - NTSB - 12/10/2002

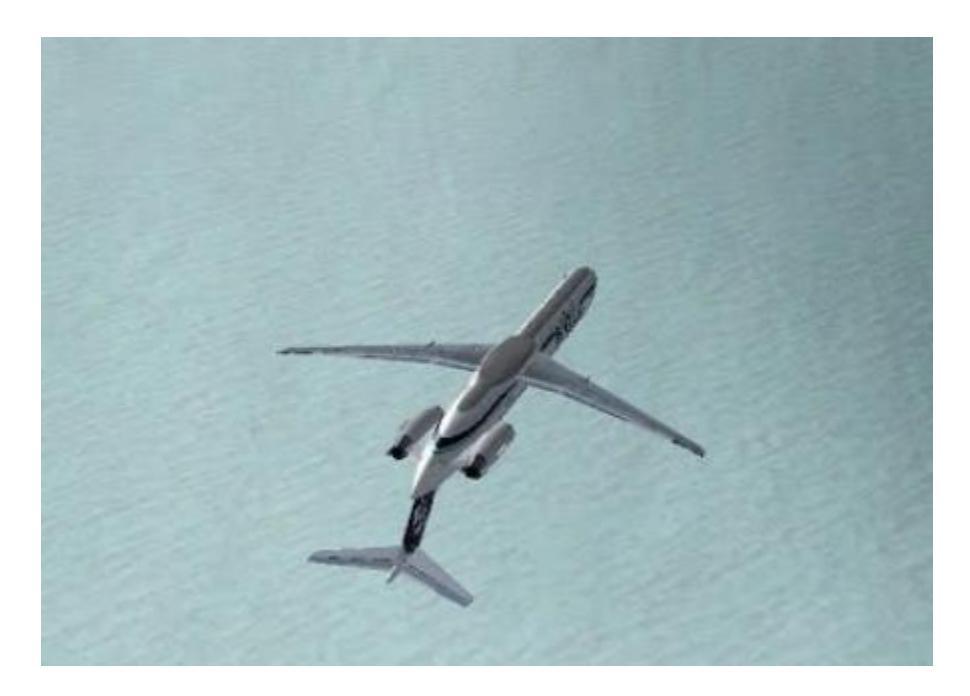
The National Transportation Safety Board determined today that the probable cause of the January 31, 2000 Alaska Airlines flight 261 accident was the loss of airplane pitch control resulting from in-flight failure of the horizontal stabilizer trim system jackscrew assembly's acme nut thread.

The component failed because of excessive wear resulting from Alaska Airlines' insufficient lubrication of the jackscrew assembly.
