Electrical Wiring Interconnect Systems (EWIS) – Recurrent Training

Wiring Inspection Examples

Presented by Sofema Aviation Services (SAS) (www.sassofia.com)

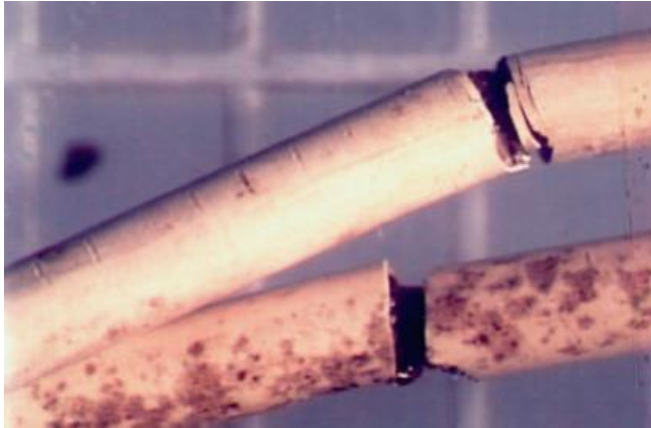
Exposed conductor under clamp, discovered during the FAA ATSRAC intrusive inspections.

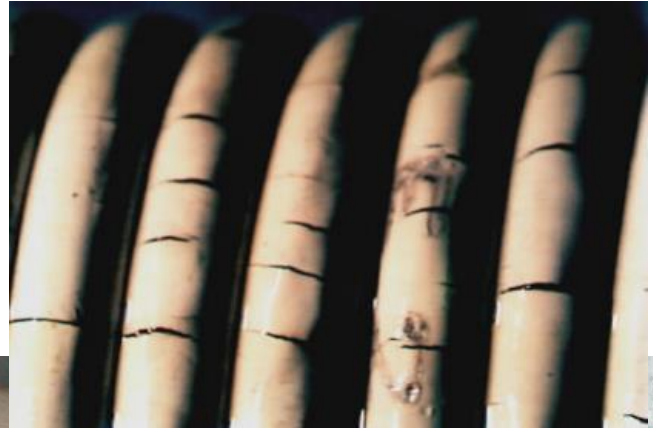
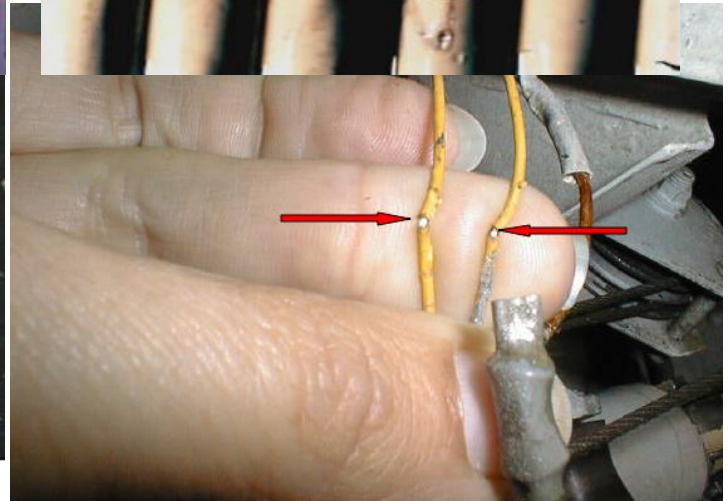
Insulation damage on a Fuel Quantity Circuit.

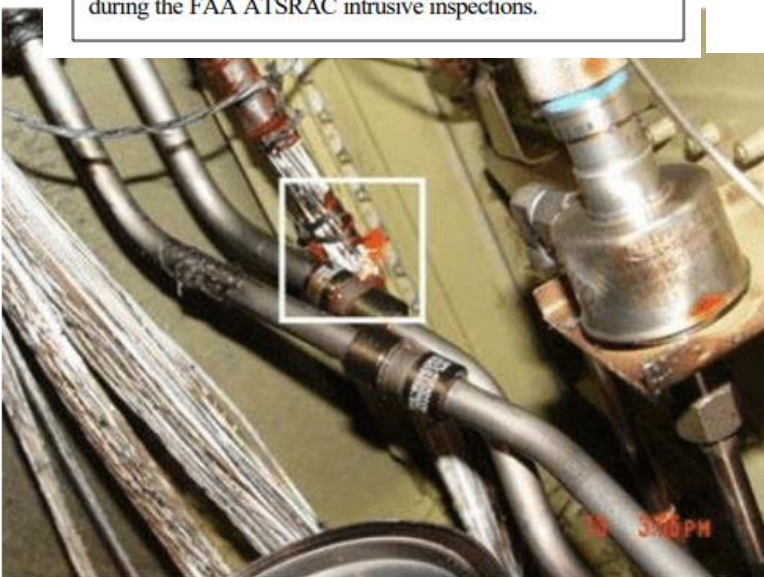
Failure initiation site is shown in the white box. Note that the wire bundle is lying on the hydraulic line. Red anti-chafe tape was used to protect the wiring.
