China_Airlines_Flight_120

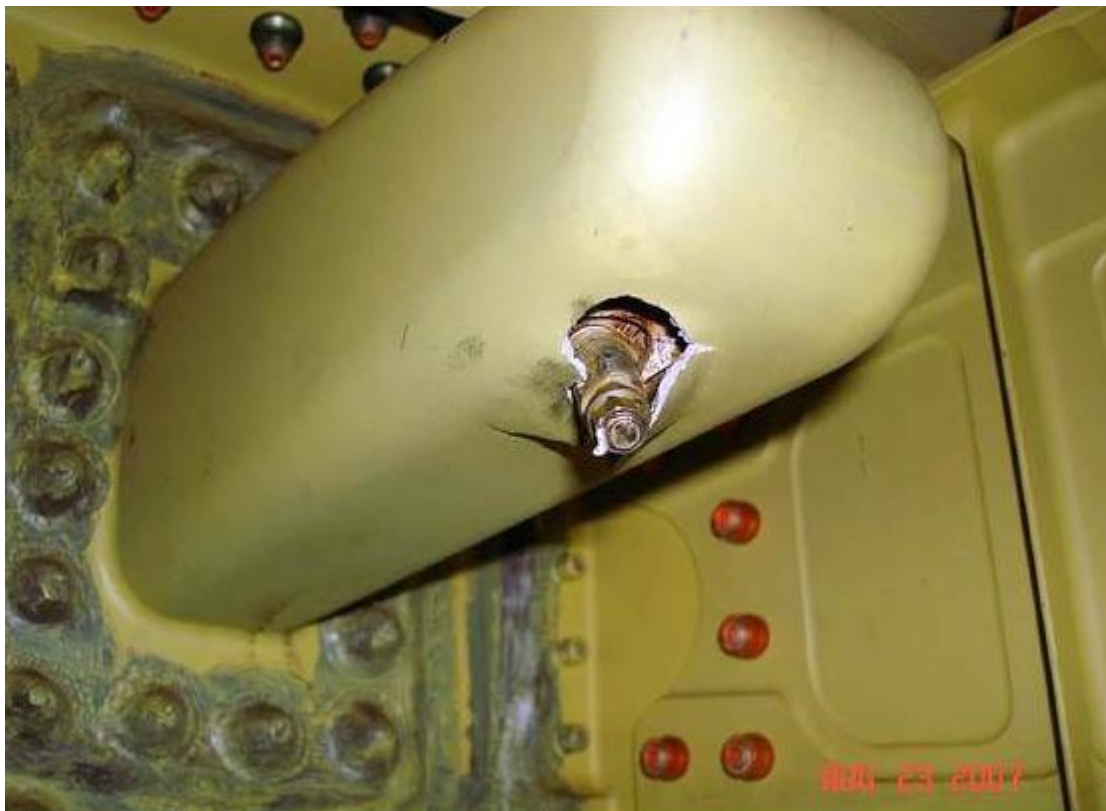
When the aircraft retracted the slats after landing at Naha Airport, the track can that housed the inboard main track of the No. 5 slat on the right wing was punctured, creating a hole. Fuel leaked out through the hole, reaching the outside of the wing.

The washer on the nut side of the assembly was omitted, following which the downstop on the nut side of the assembly fell off and then the downstop assembly eventually fell off the track.

It is considered highly probable that a factor contributing to the detachment of the downstop assembly was the design of the downstop assembly, which was unable to prevent the assembly from falling off if the washer is not installed.
