China_Airlines_Flight_120

What Happened?

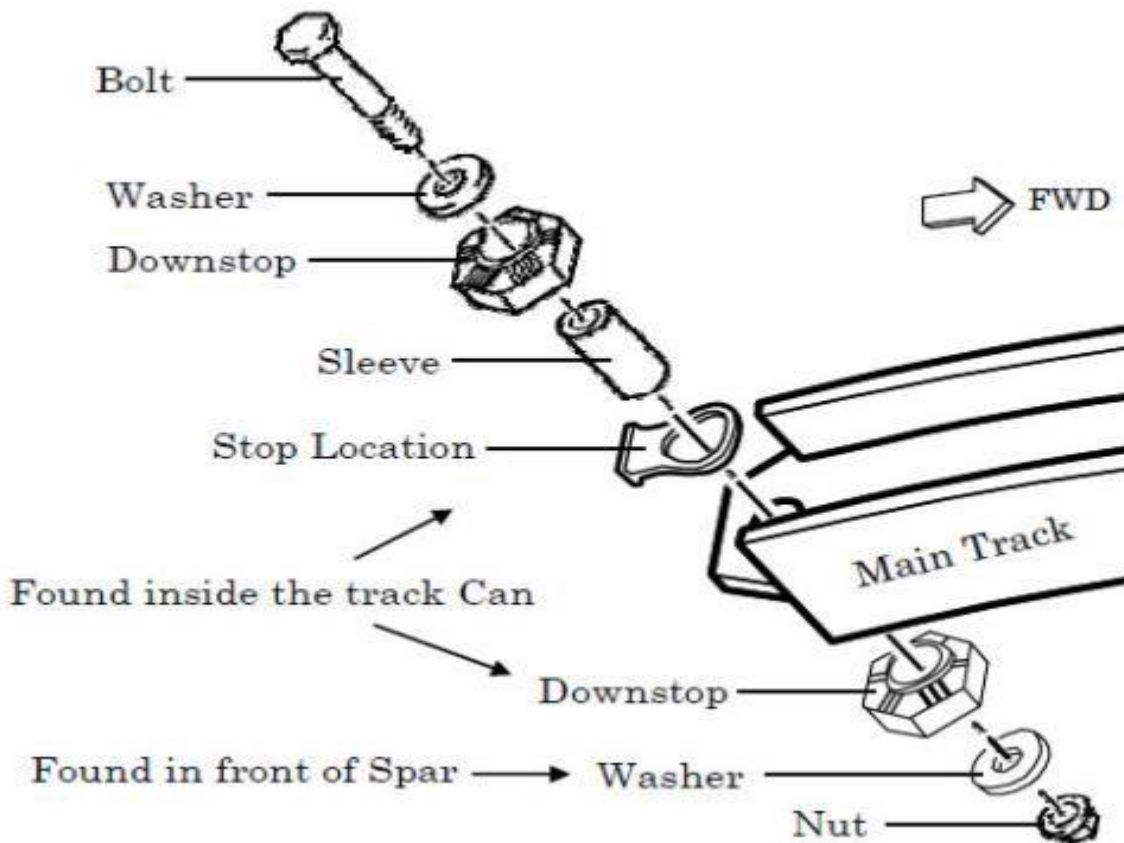
When the aircraft retracted the slats after landing at Naha Airport, the track can that housed the inboard main track of the No. 5 slat on the right wing was punctured, creating a hole. Fuel leaked out through the hole, reaching the outside of the wing.

The washer on the nut side of the assembly was omitted, following which the downstop on the nut side of the assembly fell off and then the downstop assembly eventually fell off the track.

It is considered highly probable that a factor contributing to the detachment of the downstop assembly was the design of the downstop assembly, which was unable to prevent the assembly from falling off if the washer is not installed.
