European Aviation Safety Agency

Study on visual inspection of composite structures

Visual Inspection of Composite Structures

Final Report

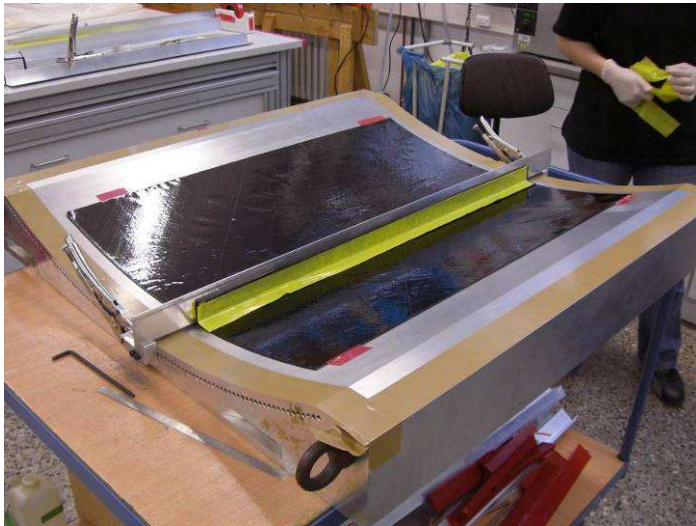
Figure 9: Placement of stringer on skin laminate. A tool with 1 m radius was used for the manufacturing test.

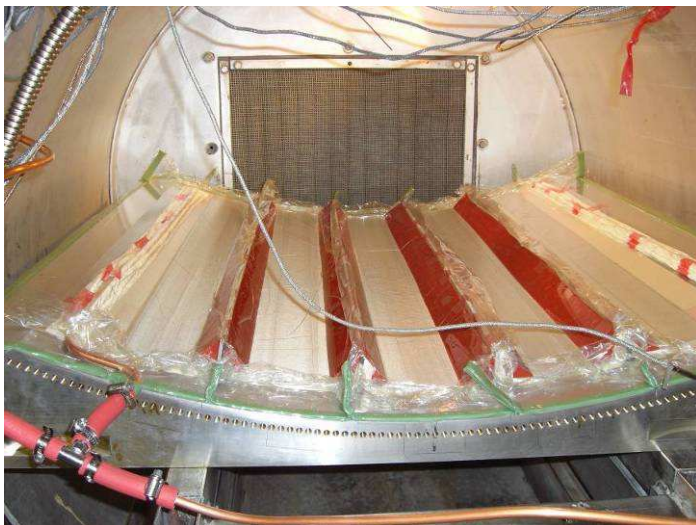
Figure 10: Stringers are supported by silicone cores (red pieces) with triangular cross sections to prevent them from collapsing during curing.

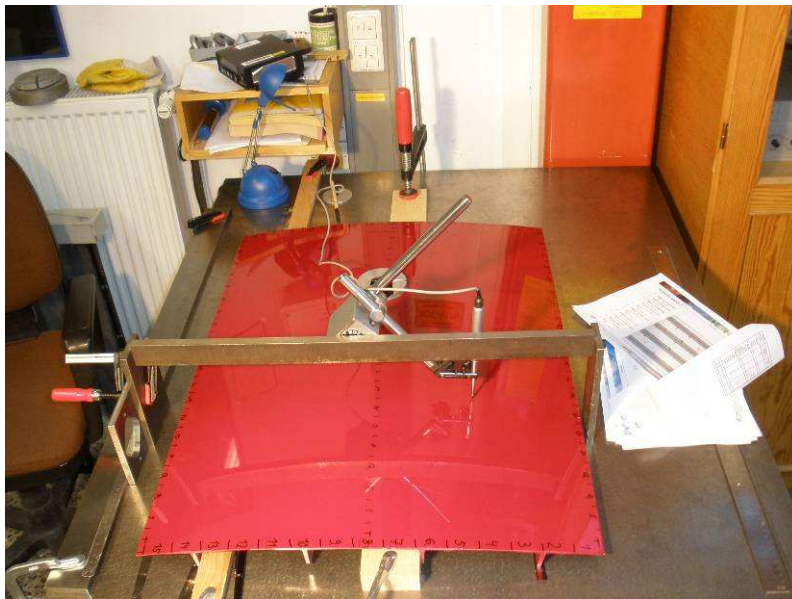
Figure 35: Set-up of dent depth measurements.

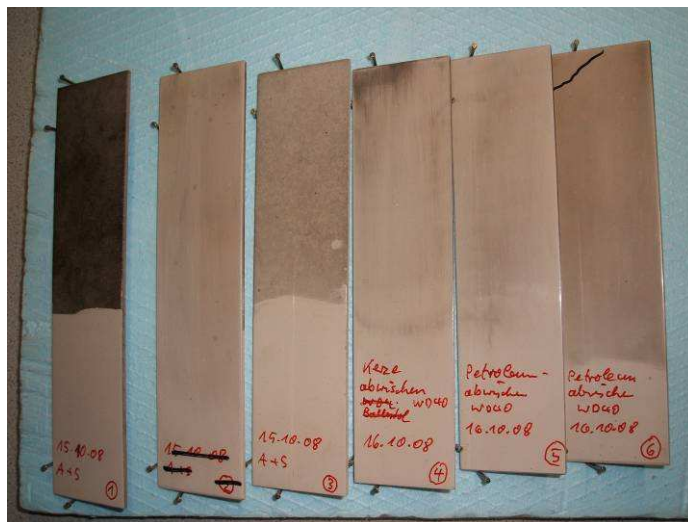
Figure 40: Trials for dirt application using acetylene soot for specimen 1 to 3, candle soot for specimen 4 and paraffin oil soot for specimens 5 and 6.

After application of different types of soot (acetylene flame, candle, paraffin oil) all specimens were completely covered with soot, like specimen 1 in (Figure 40) or even darker. Specimens 4 to 6 were sprayed with multifunction oil WD40 and wiped with a cotton cloth to adjust the amount of soot. It turned out, that the dirt film of paraffin soot / WD40 looks very much like a dirty aeroplane surface. The thickness of the dirt film is adjustable by the amount of wiping with a cotton cloth. The soot from acetylene does not stick to the specimen very well. It can be blown off the specimen

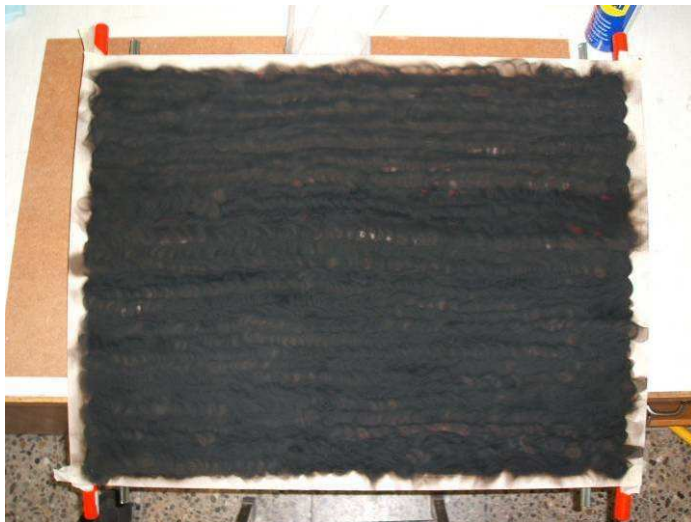
Figure 42: Panel 1 completely covered with soot from paraffin oil.

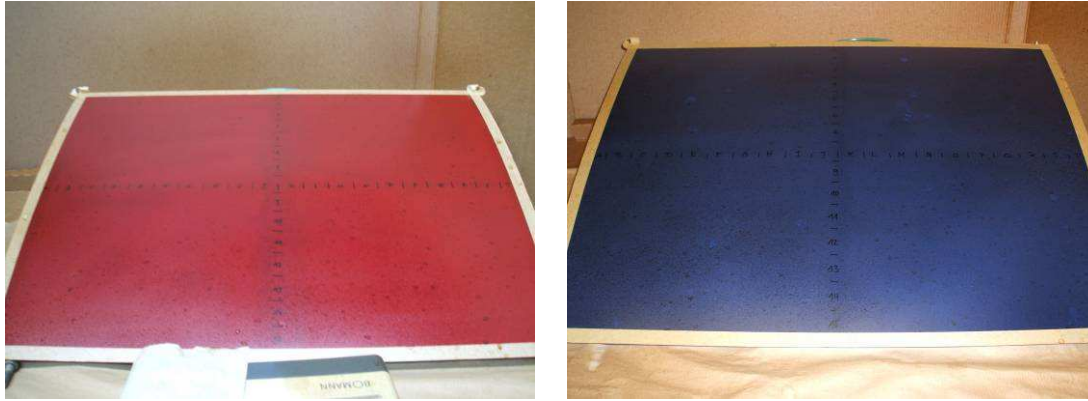
Filter coffee was brewed with a coffee machine using standard paper filters to filter out coarser particles. The coffee was then sprayed onto the panels. Warm air heated up the panels in order to accelerate the evaporation of the water, leaving a film of coffee particles behind. The process of spraying coffee and subsequently drying the panels with warm air was repeated over the course of about an hour per panel for a moderate dirtiness level and 90 – 120 minutes for “worst case dirtiness”. The result was a rather dark, matt dirt film on the panels.

Figure 45: Figure 1 coffee stain on the blue / red matt panel surfaces.

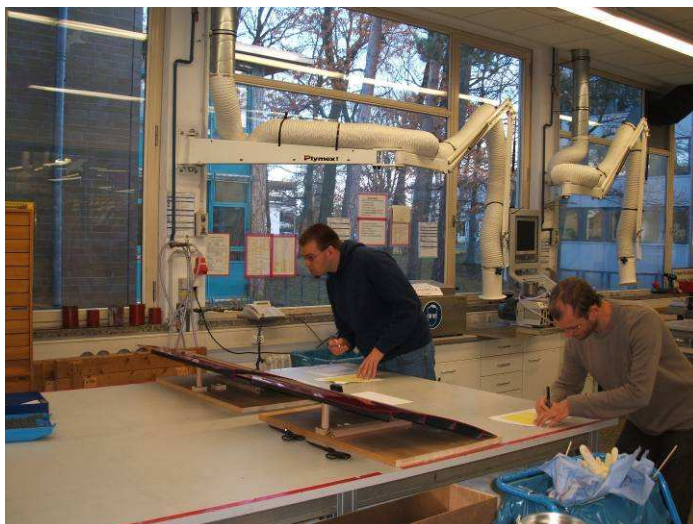
Figure 59: Inspection No. 1 at very good lighting conditions.

All inspectors found damages 6 to 10 on both panels, only one inspector missed the No. 5 damage on panel 2. Even the impact location No. 4 was found by quite a few inspectors. The US-scan did not even show internal damage here. But even the very good lighting conditions did not help much at locating the flat, spread out dents from the blunt impacts.

Inspection No. 1 was conducted with equal conditions for both panels under very good lighting conditions, see Table 22 and Figure 59.

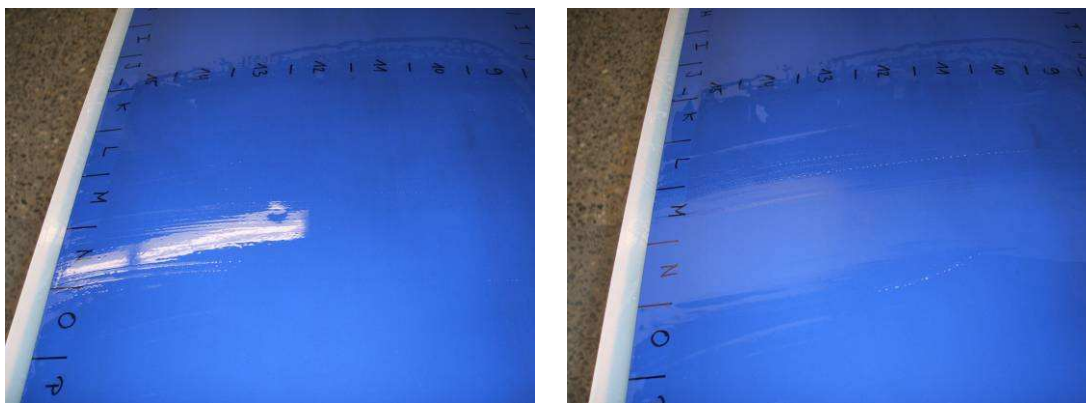
dent could be improved by wetting the surface with water and thereby creating a glossy appearance. In order to improve the detectability of small dents, the liquid film must be thin and of an evenly distributed thickness. Using pure water creation of such a thin, even water film did not succeed, because surface tension of the water resulted in the forming of water droplets, unless an excessive amount of water was used. A second experiment was performed by adding a small amount of soap to the water, in order to reduce the surface tension of the liquid. Now a thin, glossy film could be created by carefully avoiding the formation of foam. Now the difficulty was evaporation of the water film because of quite low humidity on that day, but for a short time, the water covered surface received a glossy appearance, the dent becoming clearly visible from a certain visual angle (Figure 64, left hand side). It has to be stated, though, that the impact damage, on which this was tried out, was detectable quite well also on the matt surface. The detectability of the damage on the matt surface was much better than it appears on the right hand side photo in Figure 64.

Figure 64: Surface wetting, to improve detectability of dents on matt surface.

Inspired by a publication on “enhanced visual inspection” [27], a small experiment has been conducted on the matt, blue panel 1 to find out, whether the visibility of a
